Integrated survey as a support for the restoration project of historic religious heritage

integrated survey, photogrammetry, architectural survey, TLS, cultural heritage.

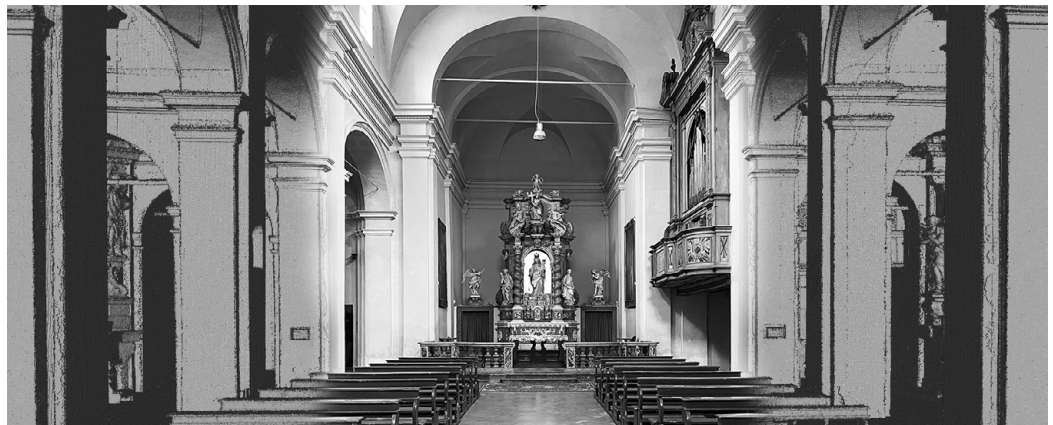
Internal view of the Church of Beata Vergine del Carmine in Soragna (overlapping of a photograph and image of the point cloud obtained from the laser scanner survey). Graphic elaboration by the authors.

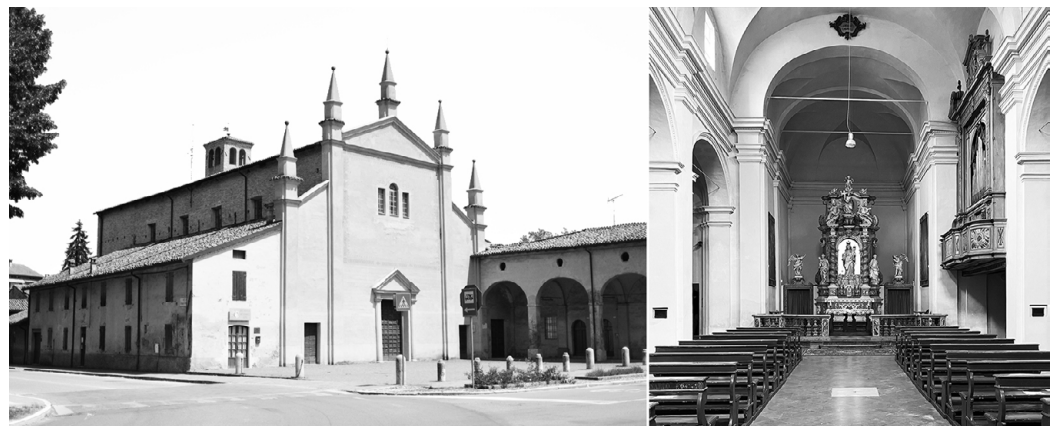
Fig. 2. Views of the church (on the left: principal façade; on the right: internal nave). Photographs by the authors.

The church of Beata Vergine del Carmine, finished at the end of the 17th century, is organized into three different naves (fig. 2). The central one, is a barrel-vaulted nave and is divided into five bays. The principal nave ends in a rectangular-plan chancel, also covered by a barrel vault, but featuring a pavilion head. Adjacent to the central space are two side naves, also divided into five bays on each side, covered by cross vaults. These side naves have a lower height compared to the central one, allowing space for eight windows that illuminate the church. At the northern end of the left nave is located the sacristy, while on the right side, connected to the principal structure of the former convent of San Rocco, stands the bell tower. Along the eastern side of the church, there is a portico covered with cross vaults that, through seven round arches, overlooks the main open space of the entire complex. This portico, surmounted by a second level housing two rooms, was intended to form one side of the convent cloister, which, however, was never completed (fig. 3).

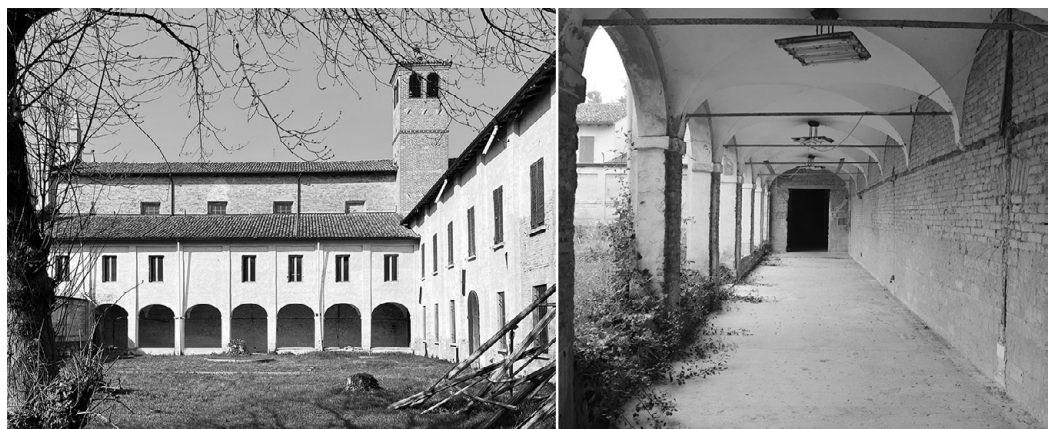
Fig. 3. Views of the former convent (on the left: external view of the portico; on the right: internal view of the portico). Photographs by the authors.

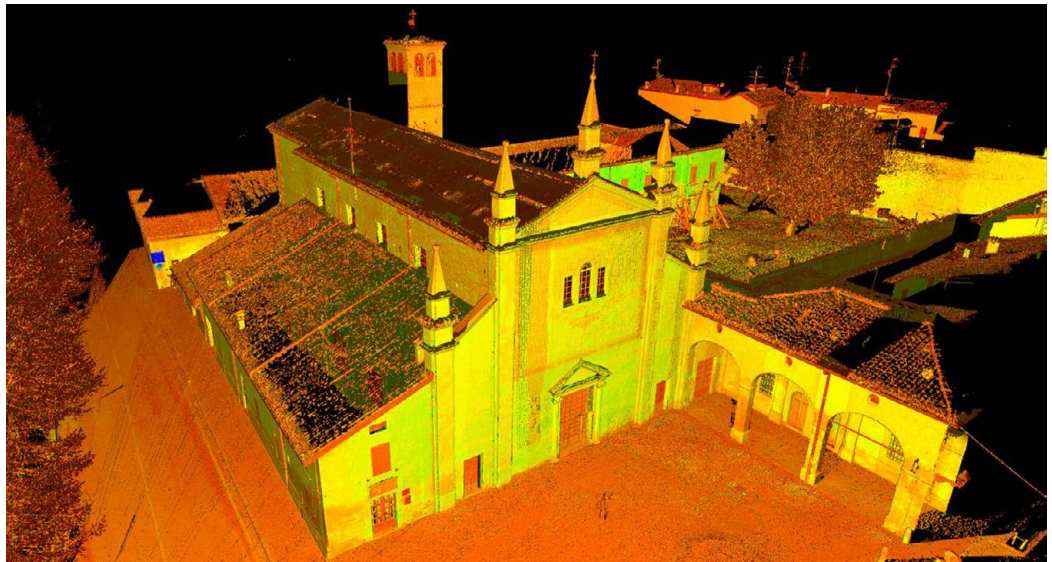
Fig. 5. Point cloud of the church obtained from the laser scanner survey. Graphic elaboration by the authors.

Subsequently, it was possible to proceed with a laser scanner survey campaign. During this phase, only a few scans were taken at the station points used for the topographic survey. To minimize shadow areas as much as possible, most of scans were made at different strategically identified points. A total of 33 scans were performed (at the lower level of the church, outside the building, in the roof spaces), setting the resolution to 10x10 cm at a distance of 100 meters. Only for scans of the main facades, a higher resolution was employed (of 5x5 cm at a distance of 100 meters). Once the laser scanner survey campaign was finished, the 33 scans were co-registered through dedicated software (fig. 5). To this aim, the targets coordinates surveyed by the total station were used. The obtained point cloud was then exported in order to be used within the automatic drawing software.

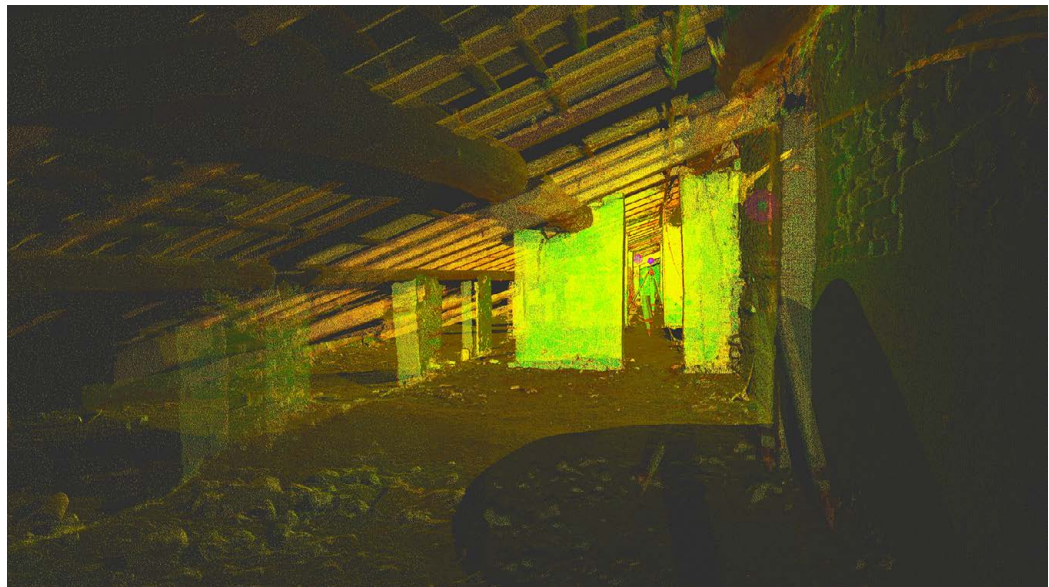
Fig. 8. Point cloud of tight and difficult-to-access roof spaces obtained from the laser scanner survey. Graphic elaboration by the authors.

Once the laser scanner survey campaign was finished, all the data were co-registered using dedicated software, obtaining a unique point cloud to use within the automatic drawing software (fig. 8). Considering the first mentioned purposes of the survey, it was decided to document the former convent through traditional two-dimensional survey drawings, at a 1:50 scale of representation. A total of nine drawings were elaborated: three floor plans and six vertical sections-elevations.
